Chapter 4: Landslide Features and Their Relative Ages

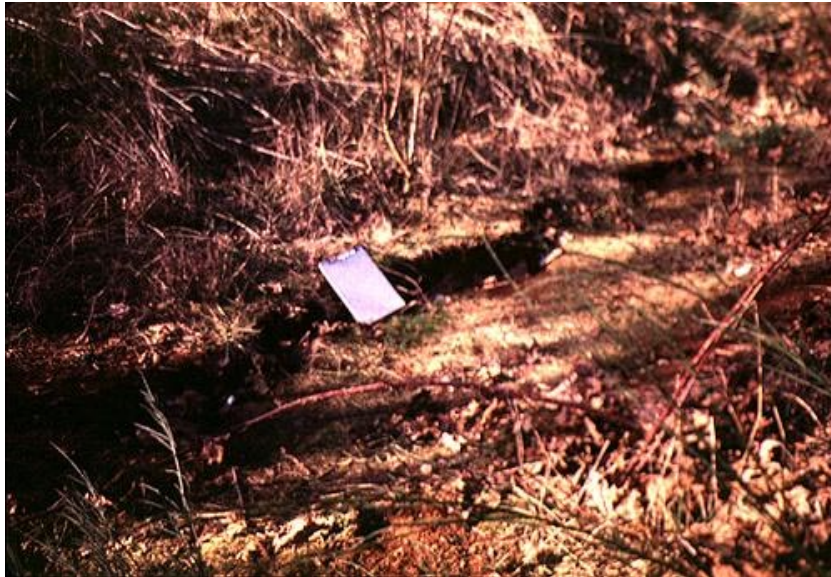
In the study area, tension cracks, when present, were mostly found above scarp-like features and along the upper portions of the flanks of active landslides (Plate 3). Tension cracks found in the study area had openings from 5 to 30 centimeters wide (Figure 7). As observed by Sha Spady during the February 1996 failure of the Spady Landslide, a tension crack ranging in width from 5 to 30 centimeters appeared on the

Figure 7: Fresh tension crack located above head scarp of the Hilltop Avenue landslide, located at the dead end of Hilltop Avenue in the southwest section of the study area ($8\frac{1}{2} \times 11$ inch field notebook for scale).

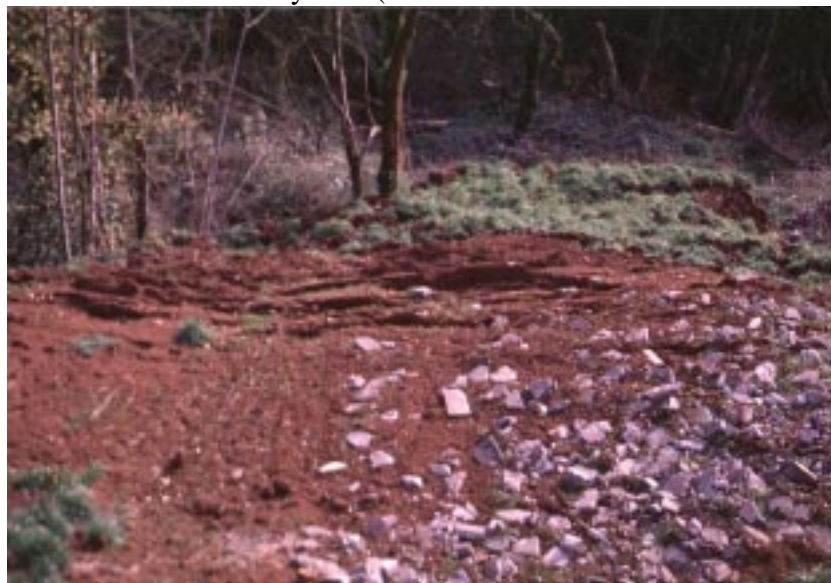
Figure 8: Transverse cracks formed as a fill failure flows over the lesser disturbed natural stratigraphy. View looking down at west R & B Leasing landslide.

Transverse cracks, although seldom found, were always located within the moving masses. On the R & B Leasing property, located on Morton Road (near Highway 213), one of the slides occurring in man-made fill had a series of transverse cracks where the fill flowed over a bench (Figure 8).

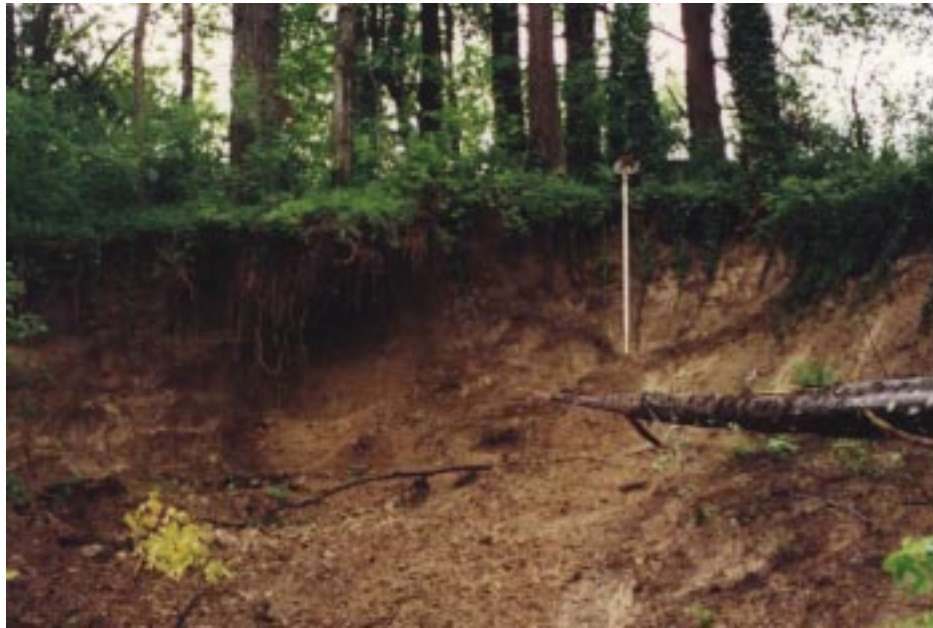
Among the features found in the study area resembling scarps, many of them associated with active landslides displayed a continuous, steep, bare soil escarpment, with a concave downslope shape in map view (Figure 9) (Plate 3). Other scarp-like

Figure 9: View looking up at head scarp of the Spady Landslide after the February 1996 failure displaying a continuous escarpment of bare soil with a concave downslope shape. This is typical of a fresh head scarp on an active landslide (plane table survey rod = 15 ft).

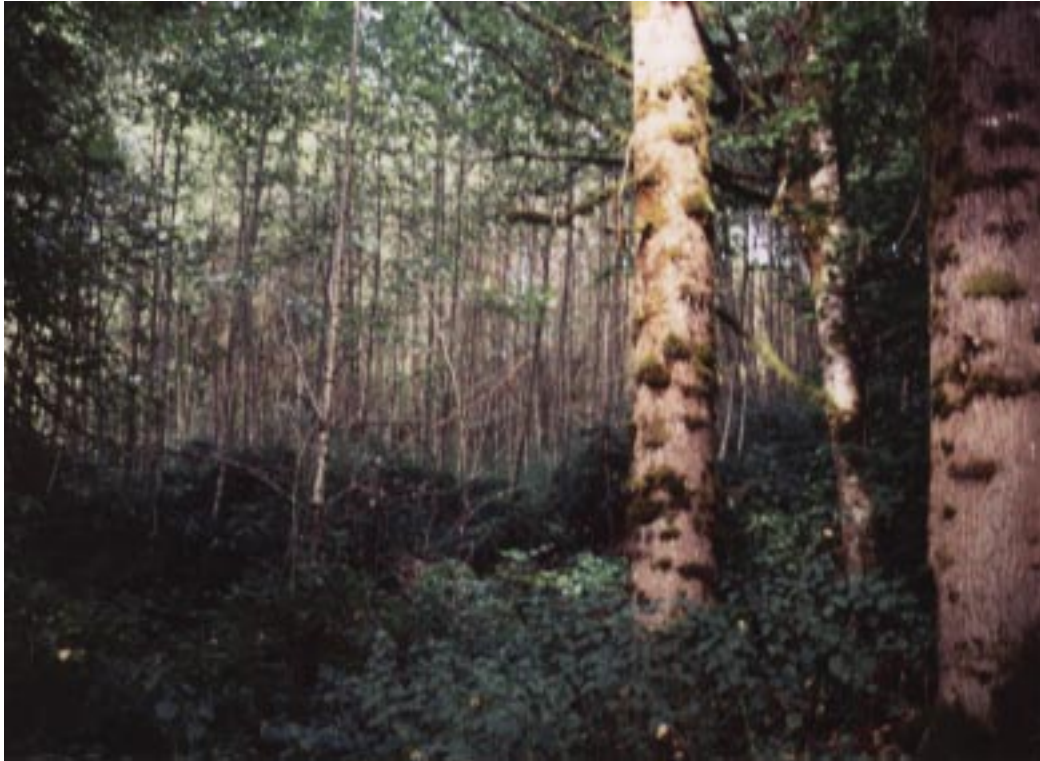
Figure 10: Change in vegetation size, from large (older) trees in the foreground (left side of picture) to smaller (younger) trees in the background (on landslide), divided by a shear zone marked by a small gully. This slide is located in the northern portion between Newell Creek and Highway 213.

size or age of the vegetation helped to distinguish shear zones (Figure 10). Other shear zones sometimes appeared as erosional gullies in the direction of the slope.

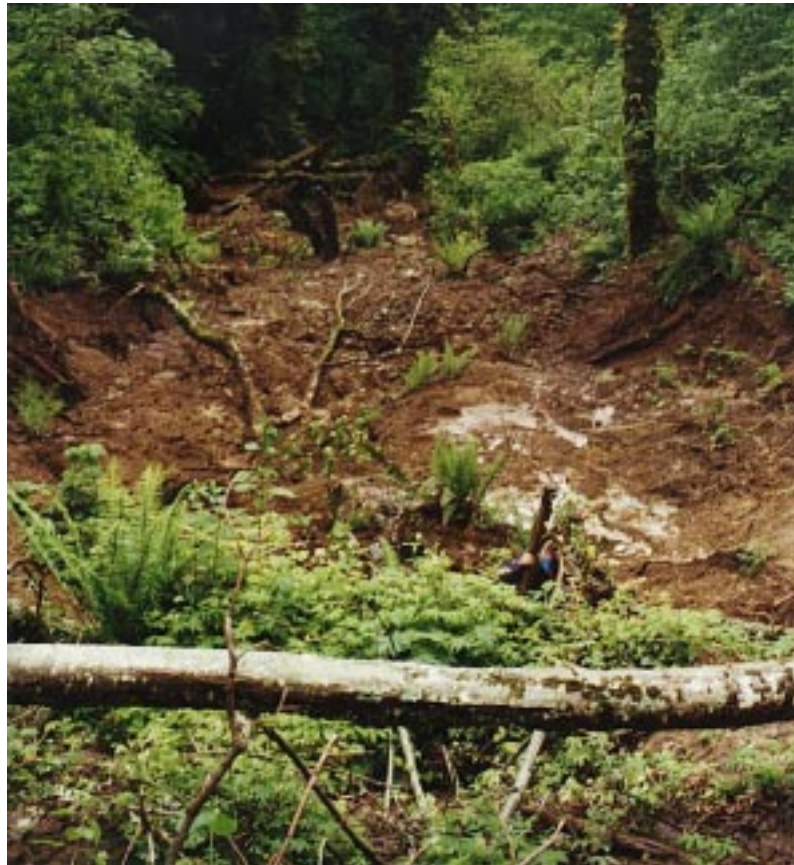
In the study area, these debris flow deposits appeared as creek channels filled with soil and debris with marginal levees of displaced material (Figure 11). These debris flows also have steep thrusts (toe compressional features) where the material flowed around a corner or where the material came to a stop (snouts). In one case (March, 1997 failure of the Spady Landslide, located at the end of Alden Street), a debris flow traveled the length of the creek (approximately 60 m) and into the merging creek, where it blocked the merging creek, damming it and ponding water up the merging creeks valley to an estimated depth of two meters (Figure 12 and Plate 3).

Figure 11: View down the debris flow filled channel below the Spady Landslide after the first failure (February 1996), displaying marginal levees and creek channel filled with soil/debris. It is approximately 15 meters wide and extends for approximately 60 meters beyond the large, downed tree in foreground.

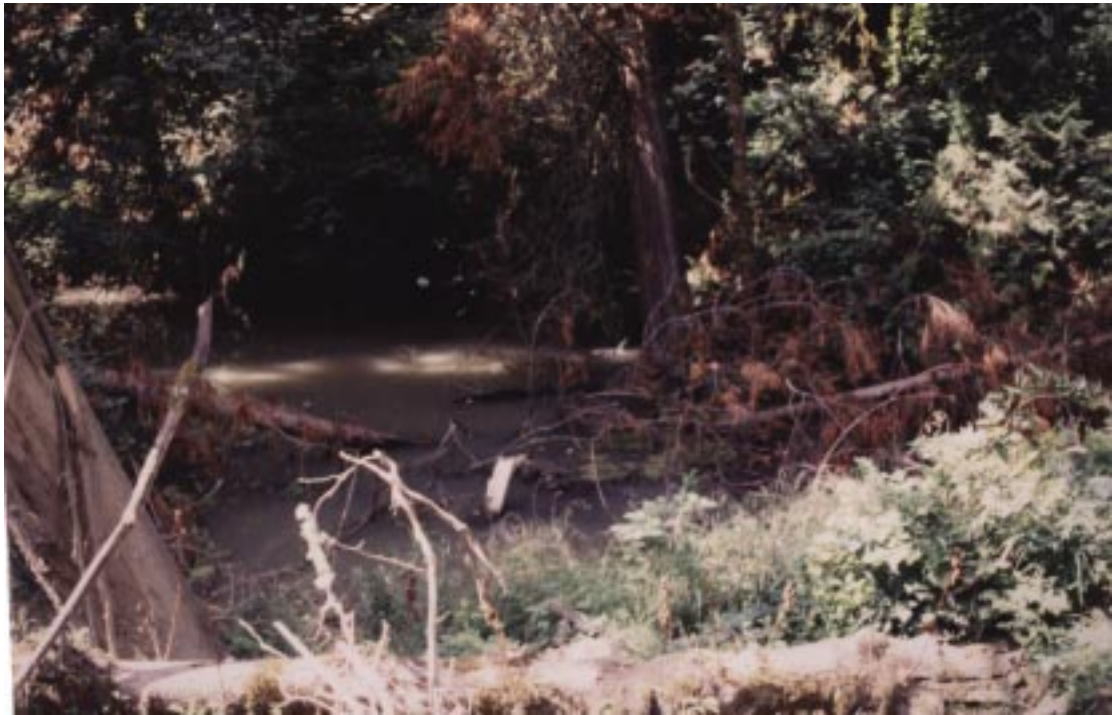
Figure 12: Poned channel caused by debris flow from the second failure (March 1997) of the Spady Landslide.
